On the Weakening of Weathered Window Glass and Its Effect on Human Impact Resistance: Two Fatality Case Studies

MARK MESHULAM

2019 IIBEC Building Enclosure Symposium

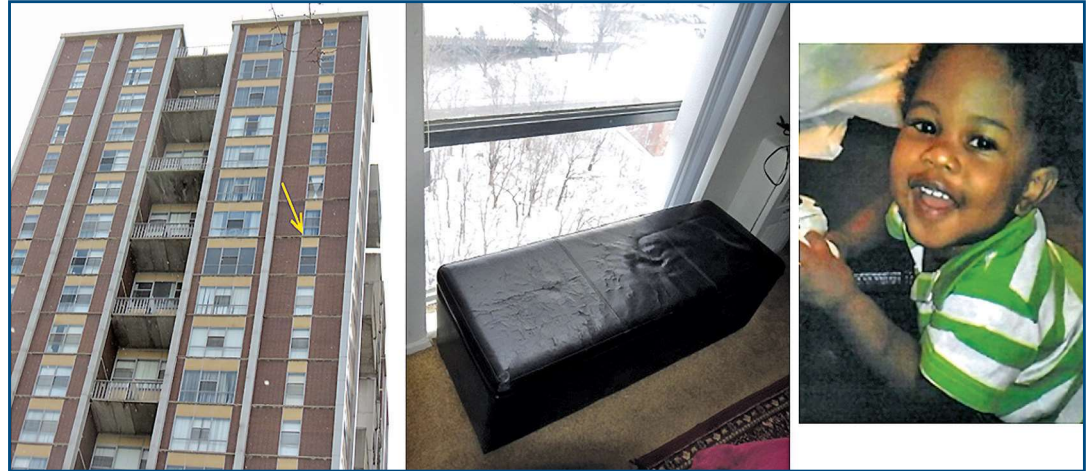
Alijah Glenn (Figure 1, right) was playing with his 3-year-old brother in their grandmother’s 17th-floor apartment (Figure 1, left) in Crystal Tower Apartments, East Cleveland, Ohio, on January 13, 2014. He placed himself in a narrow space between a nearby ottoman and a floor-level window (Figure 1, center). He broke through the monolithic non-safety glass and fell to his death. The only eyewitness was his brother. The family’s civil suit against the property settled prior to trial.

Figure 1 – Left: Crystal Tower Apartments with arrow indicating incident window. Center: View from inside of incident window. Right: Alijah Glenn.

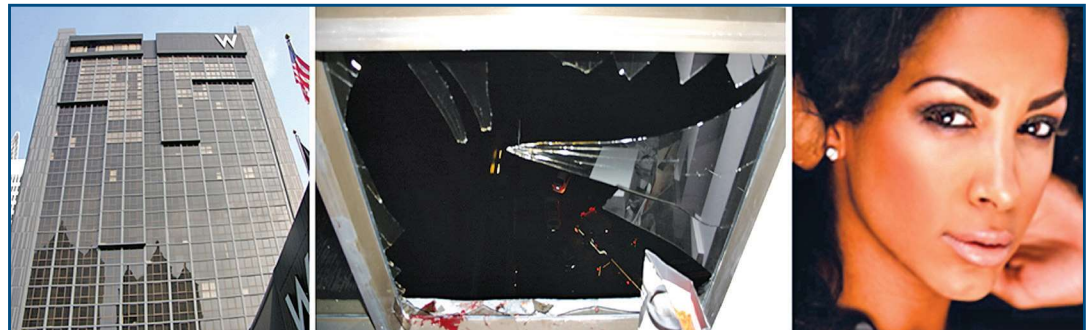
Figure 2 – Left: The W Hotel, Atlanta. Center: Incident window. Right: LaShawna Threatt.

model and mother of a daughter, was celebrating her 30th birthday on May 27, 2011, in the W Hotel in the Midtown neighborhood of Atlanta, GA (Figure 2, left). After dinner, a small group of friends came up to Threatt’s tenth-floor hotel room to continue the celebration. Threatt and her friend Cierra Williams were joking while crouching with their backs to the floor-level window, which was glazed with monolithic non-safety glass (Figure 2, center). They leaned against the glass, and it unexpectedly broke. Both women fell backward through the glass and fell to the sloped glass skylight eight floors below. Threatt died. Williams rolled down the skylight, fell off its edge, and dropped an additional distance to the pavement. She survived with permanent injuries. There

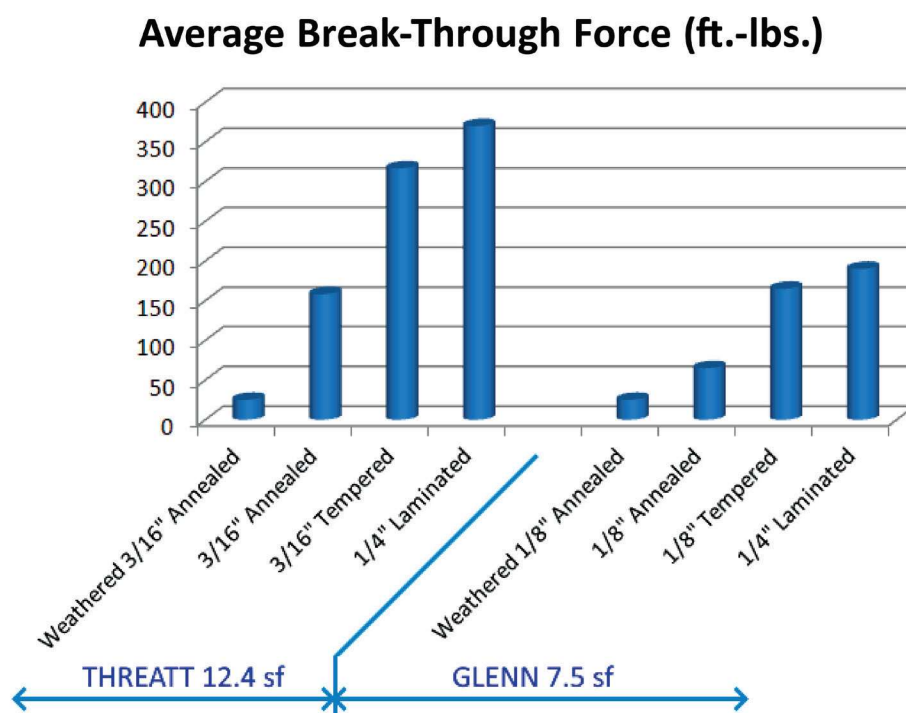
Figure 12 – Average break-through forces for each glass type, both incidents.

Test results for both incidents were consistent in demonstrating that weathered glass is severely degraded over time with regard to impact resistance. Further, the safety glasses (tempered and laminated) were found to be far superior against break-through when compared with annealed glass.

It is hoped that this information will sensitize building professionals to dangers posed by weathered glass in buildings, especially when it is non-safety glass at floor level. Armed with this knowledge, building inspectors should be better equipped to warn clients that dangerous conditions exist. Code writers are encouraged to strengthen language about requiring safety glass to be retrofitted in older buildings and disallowing the “grandfathering” of unsafe
